## CASE STUDY : PHOSCRETE HC

### Bridge Expansion Joint Header

**Location:** [US-64 SB Rocky Mount NC](#)

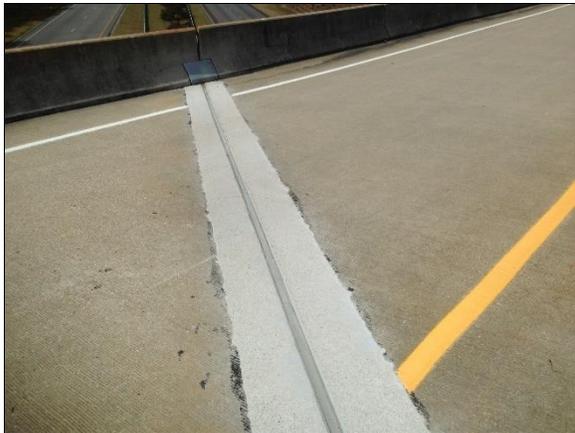
*6 month Inspection 9/18/2013*

**Reinspection Notes:** Phoscrete repair shows some hairline cracks (less than .2mm) but zero debonding, delamination, or shrinkage. Elastomeric material showed extensive debonding and pitting. Additional photos can be viewed at this [Google Photos Link](#).
