# CASE STUDY : PHOSCRETE HC

## Bridge Deck Patches

**Location:** [Stockton Channel Bridge, CA](#)

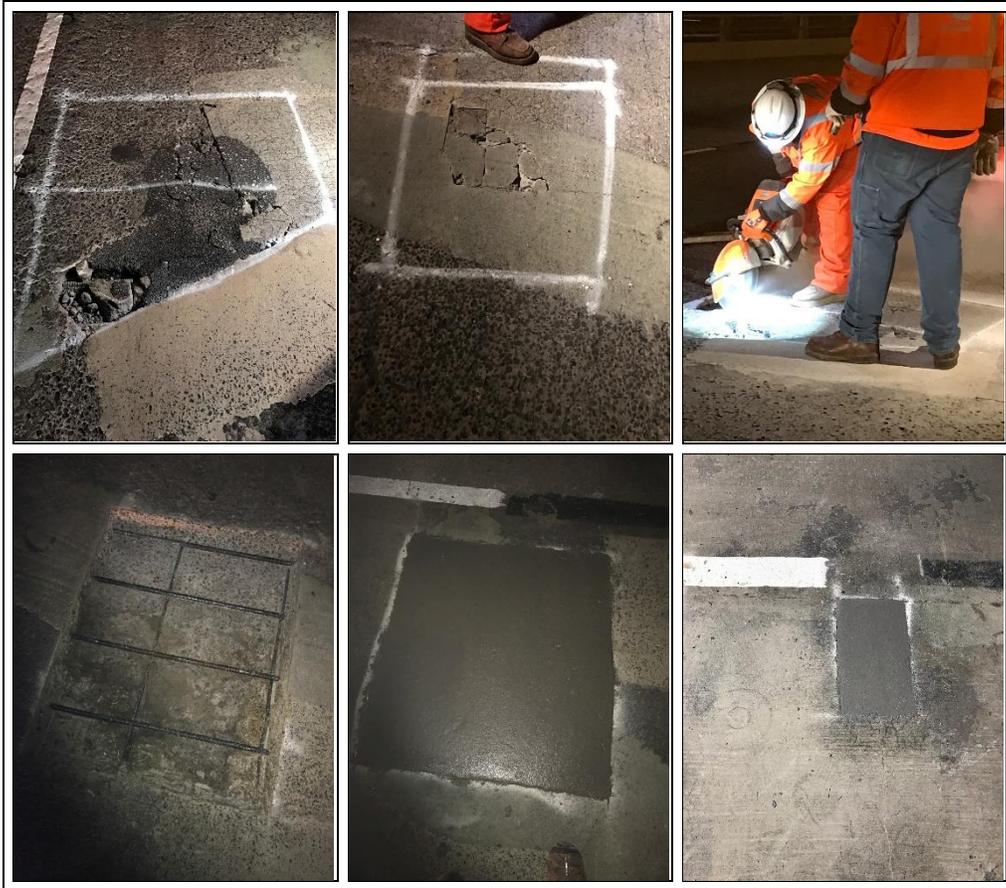
**Installation Notes:** Heavy traffic runs on this I-5 bridge across Stockton Channel. Aerial view shows a mess of bubble-gum deck patches in various states of failure. Phoscrete was installed on multiple spalls on a cold Sunday night in 2016. Demolition began at 11PM, Phoscrete was poured at 2AM and all patches were completed by 3AM, The interstate was ready for Monday traffic before 5am.
