CASE STUDY : PHOSCRETE HC

Bridge Expansion Joint Header

Location: [I-5 Nisqually River, Olympia WA](#) **Ambient Temperature:** [60°F, Night](#)

Agency: WSDOT Olympic Region

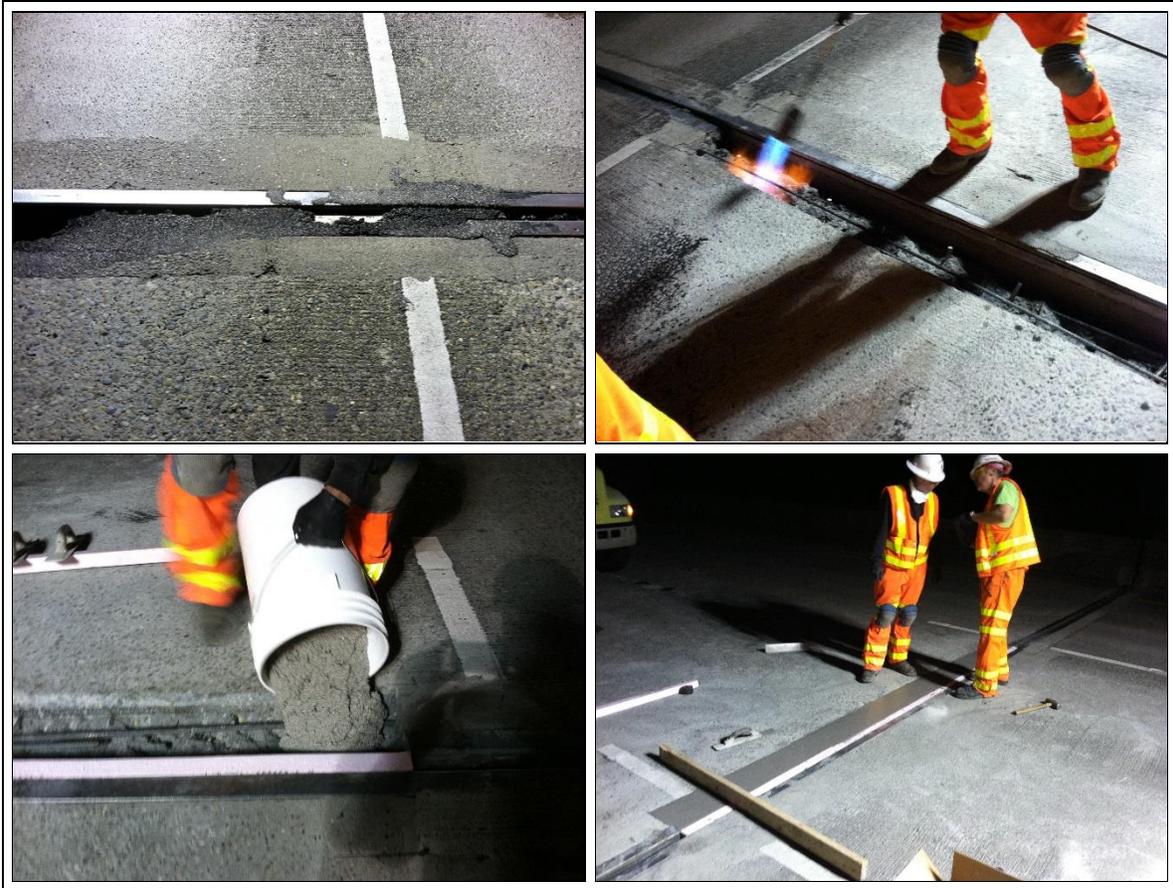
Installation Notes: Damaged armor angle required rapid repair on heavily trafficked interstate. Armor angle was removed, concrete demolished, rebar tied down, remnants from the old asphalt patch were torched off. Phoscrete was mixed, placed, finished, and ready for traffic in 3 hours.

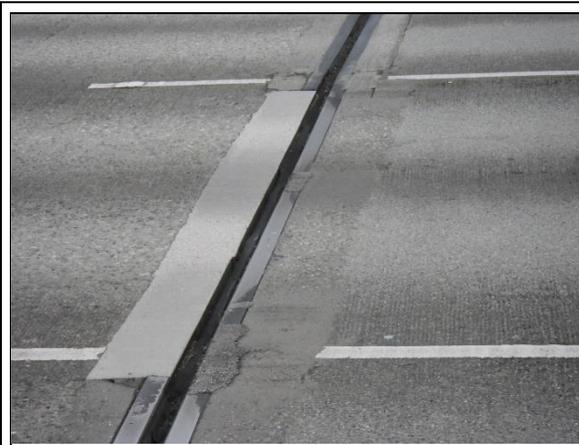
6 month Inspection 12/20/2011

Reinspection Notes: Multiple visits over 5 years show no shrinkage, no cracking, and no delamination of the expansion joint header.
