## CASE STUDY : PHOSCRETE HC

### Form and Pour Spillway Repair

**Location:** [Folsom Dam, Folsom CA](#)

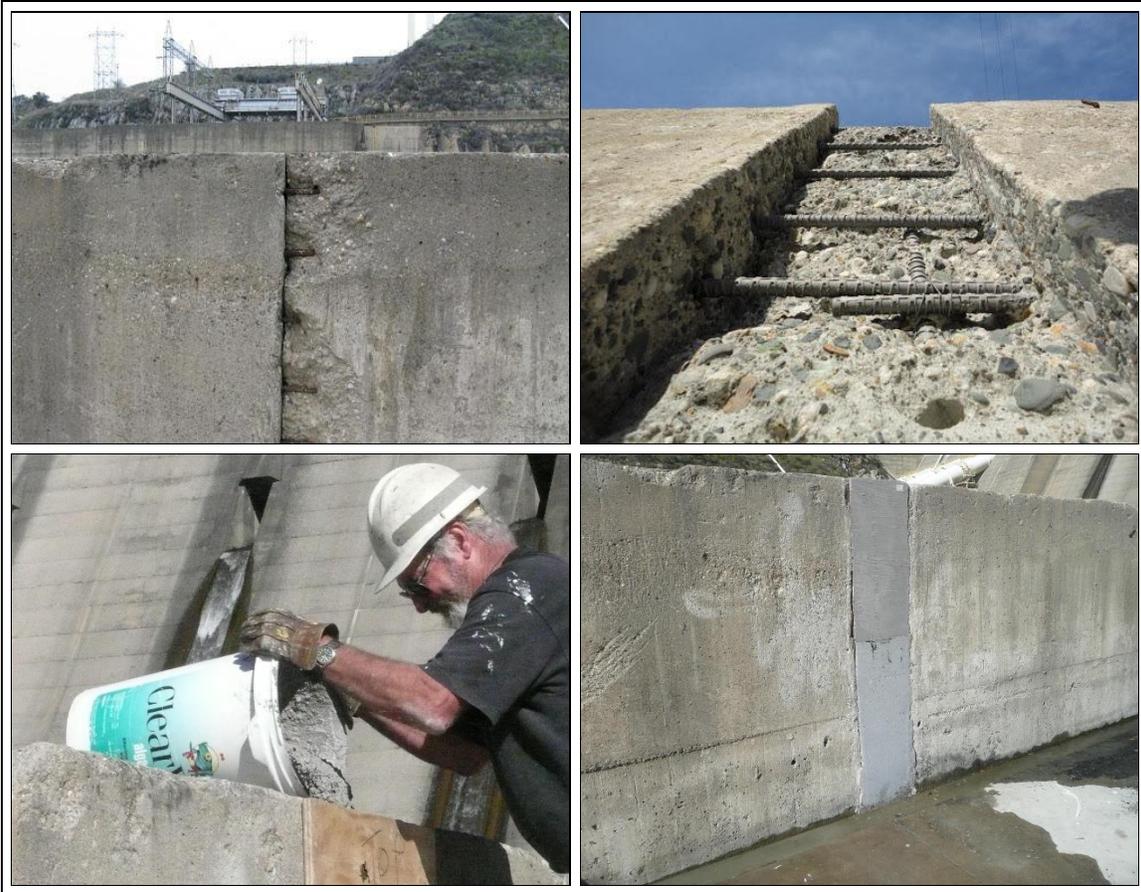
**Installation Notes:** Spillway wall was spalled. Damage concrete was removed by sawcut and chipping. Plywood forms were used to serve as a bond-breaker between the panels and also to form up the repair. Phoscrete was cast-in-place and the forms were removed after 30 minutes.

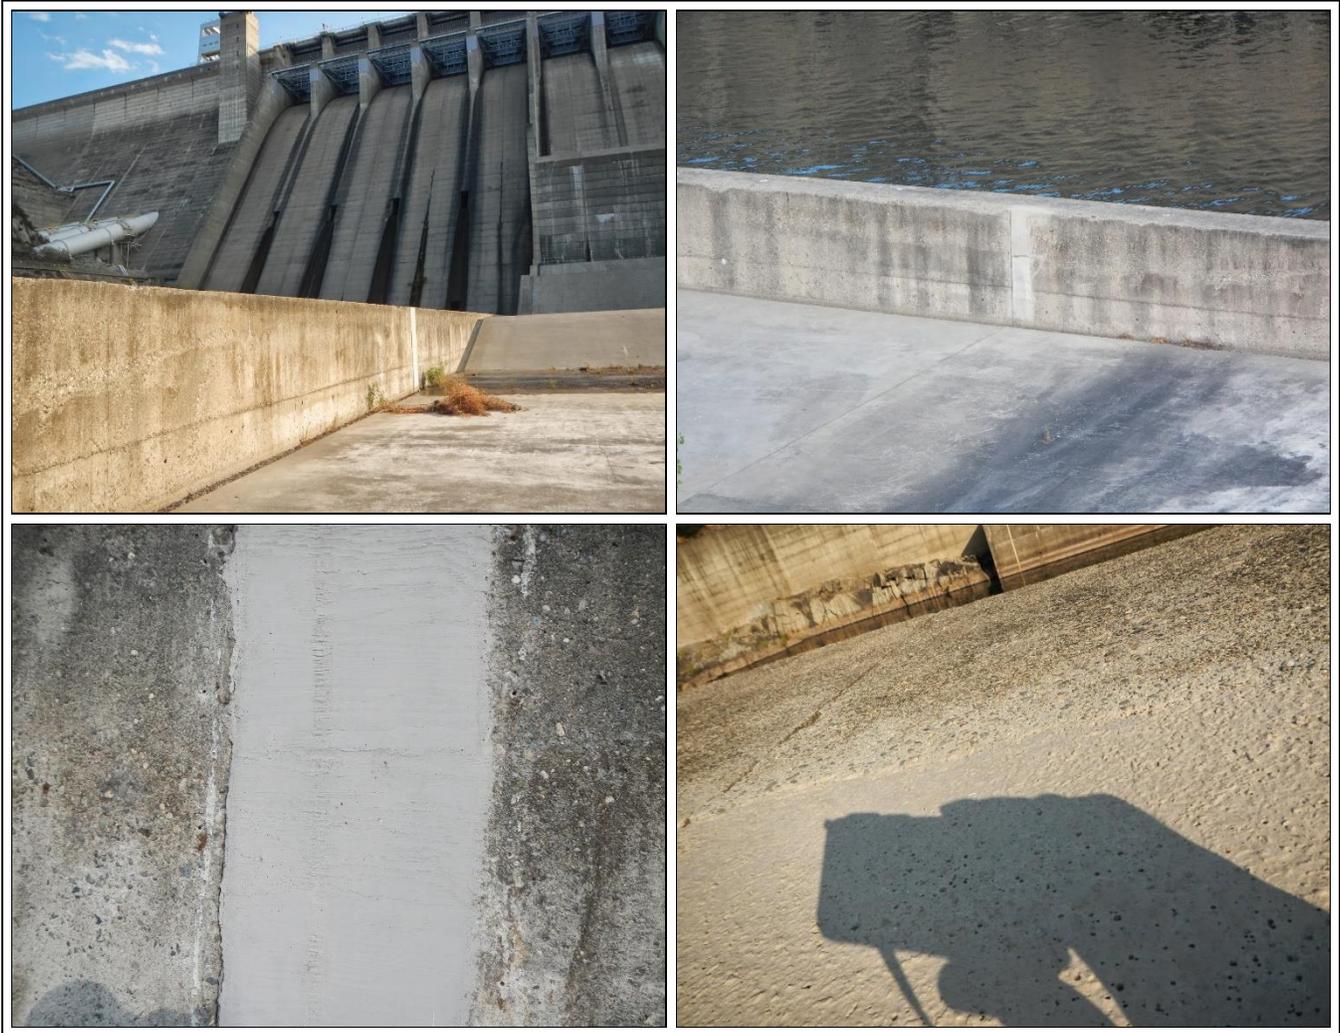
**Reinspection:** 29 July 2014 Phoscrete repair was solid in place with no shrinkage, no cracking and no delamination. Last photo is a view from the top of the repair. Additional Phoscrete material was purchased and installed by USBR maintenance personnel for various vertical and horizontal repairs on the Folsom Dam premises.
