## CASE STUDY : PHOSCRETE HC

### Bridge Expansion Joint Header

**Location:** [US-64 SB Rocky Mount NC](#)

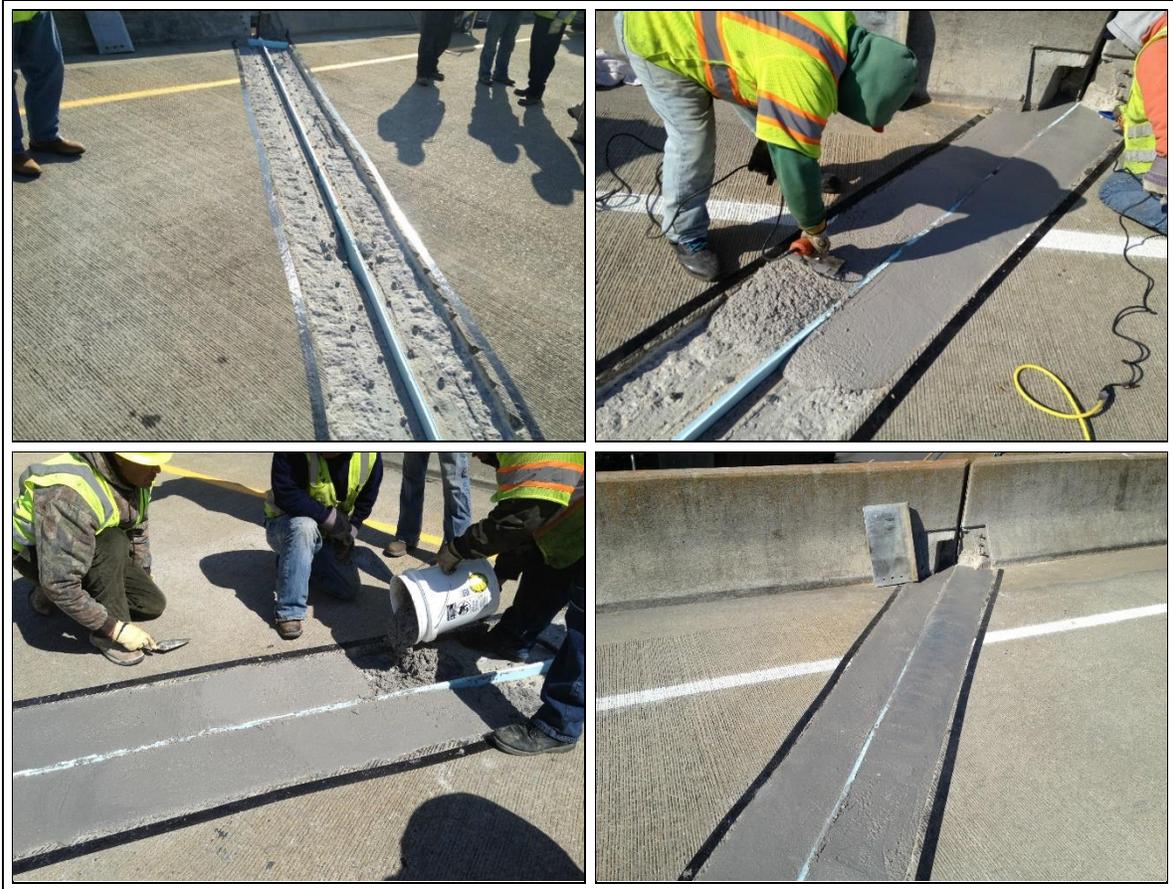
**Reinspection Notes:** Phoscrete repair shows some hairline cracks (less than .2mm) but zero debonding, delamination, or shrinkage. Elastomeric material showed extensive debonding and pitting. Additional photos can be viewed at this [Google Photos Link](#).
